TEST REPORT

No. : XMIN2008007979CM

Sample Name : SPC FLOOR

Test Item: Slip resistance

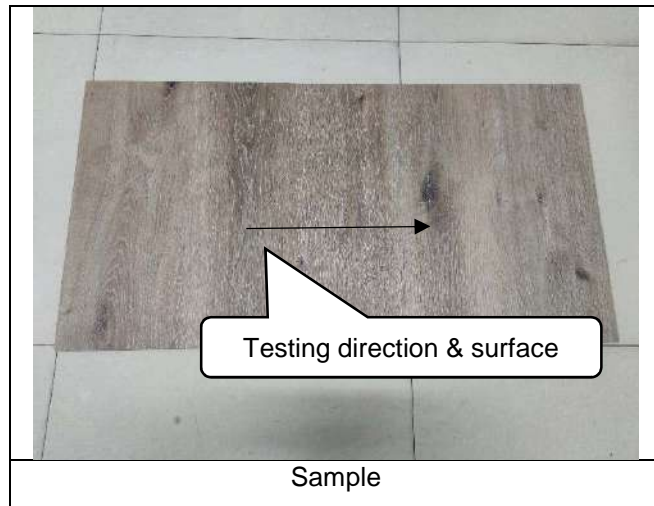
Original Sample Photo:

No.	Test Item	Test Method	Result
1	Slip resistance	AS 4586-2013 Amdt 1-2017 Annex D	Critical angle of inclination: 15.2° Classification: R10

Sample Description: Flooring, See photo

Specimen: 970mmx505mm, 1pc, see photo

Test item(s)	Test result(s)	Classification
Slip resistance (oil-wet ramp test)	Critical angle of inclination: 15.2°	R10
